The Life Cycle of Your Roof

Homeowner's Guide: What to Expect From Your CertainTeed Roof

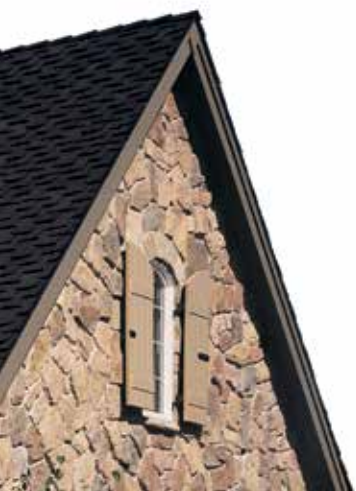
CURLING: As the asphalt hardens over time, the granules which were once securely embedded begin to break away. Occasionally you may have seen the colored granules in your gutters. Also, as this hardening advances, the asphalt layers begin to shrink. Of course, all of this is occurring at a microscopic level and is not something which will be noticeable on a daily basis. As the asphalt layer shrinks, it is being countered by the shingle reinforcement, which resists shrinking. We now have a situation in

which the top and bottom coatings are shrinking and the reinforcement is remaining stable. As a result, the edges of the shingle may begin to curl over time. In addition, organic shingles may exhibit signs of curling which might be considered excessive, however, this is not a manufacturing defect and would be considered part of the normal weathering process of organic shingles.

SURFACE CRACKING: Another manifestation of the normal aging process may be the development of surface cracks. For example, as the flexibilizing oils of the asphalt are depleted due to heat, the shingle becomes more brittle, to the point where surface cracking may appear. The stresses created by thermal shock and the movement of the roof deck also increase the likelihood of surface cracking.

Curling

Applique Surface Cracking

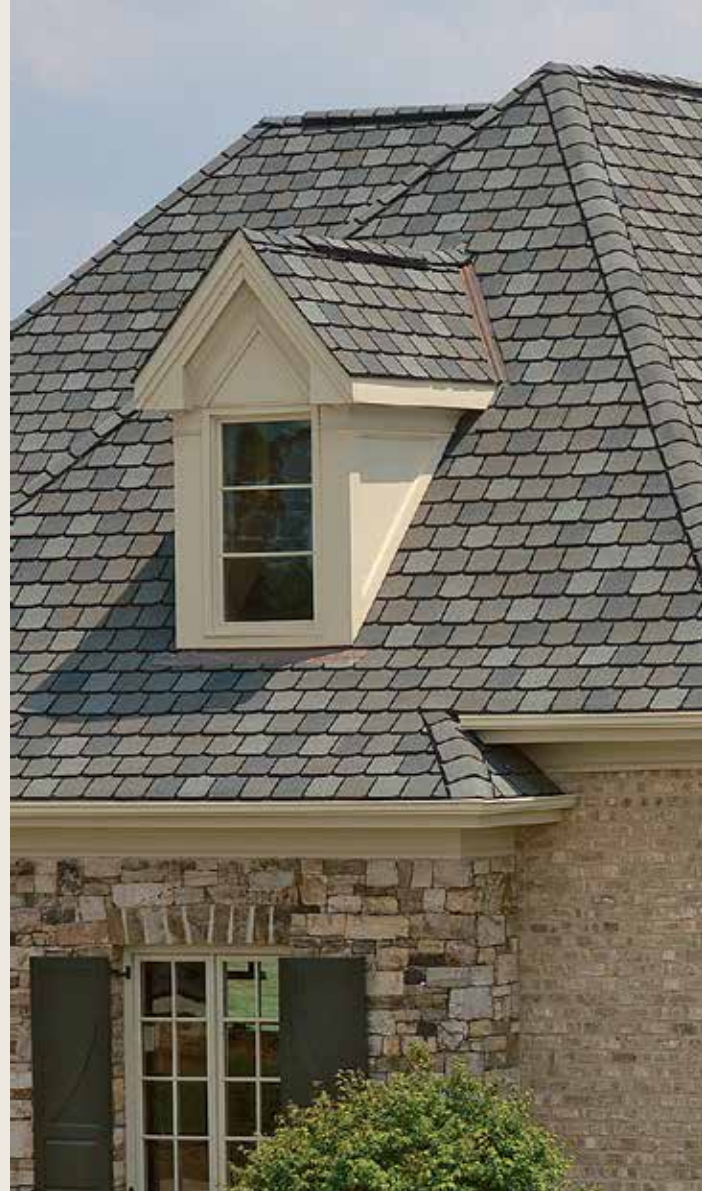
BLISTERS: During the course of natural weathering, small bubble-like raised areas known as blisters may appear on the surface of the shingles. The blisters may be small and pea-sized or as large as a quarter. The blisters may be open, exposing the asphalt, or closed. Blisters frequently result when minimum ventilation requirements are not met.

Staining: Finally, over a period of time, shingles may develop dark brown or black streaks that are sometimes mistaken for soot, dirt, moss or tree droppings. In actuality, this discoloration may be caused by algae growth. Although most roofing systems are susceptible to algae discoloration, it is most readily visible on white or light-colored shingles.

CURLING

Initial Curling

Mid-Life

Declining Years

Blisters

Algae Stains
